BEAR CREEK WATERSHED STRUCTURE B-26

SCOTLAND COUNTY, MISSOURI

MO 10981

PHASE 1 INSPECTION REPORT NATIONAL DAM SAFETY PROGRAM

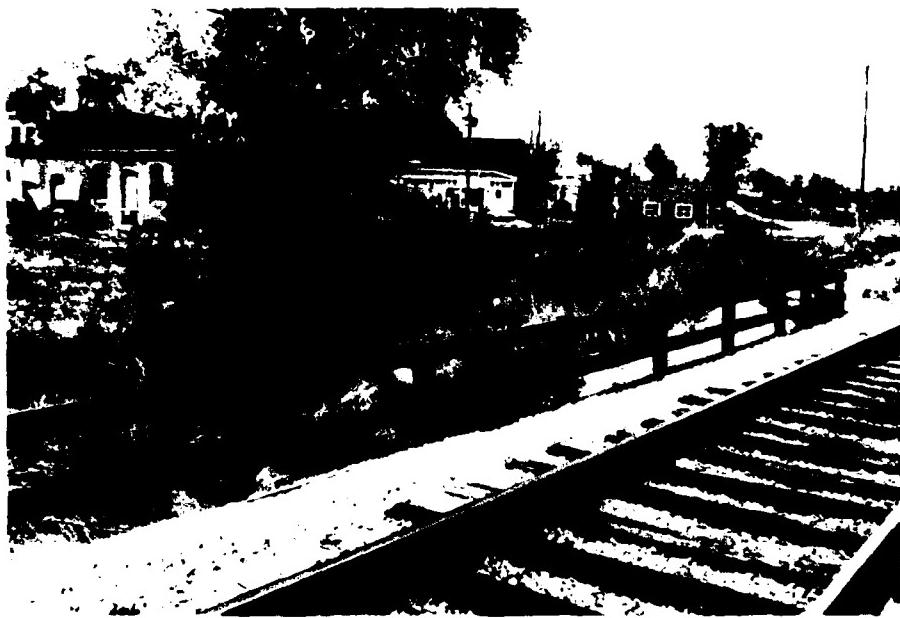
The estimated damage zone is described in Paragraph 1.2d in this report. Photos 17 through 21 show the conditions in the damage zone.

PHOTO NO. 17 - COMMERCIAL BUILDINGS IN GORIN DOWNSTREAM FROM RAILROAD BRIDGE..

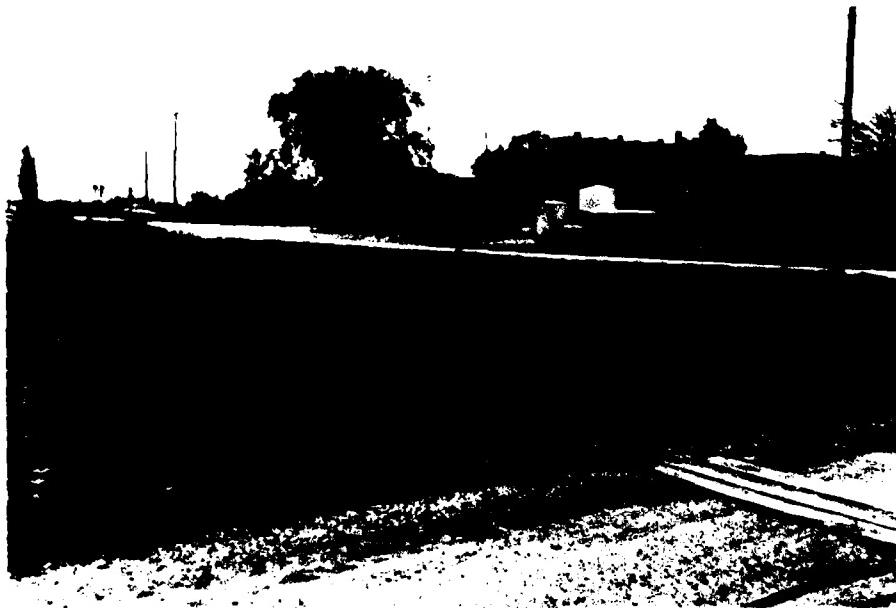
PHOTO NO. 21 - VIEW UPSTREAM FROM BRIDGE SHOWN IN PHOTO NO. 20. BOX CULVERT AT LEFT IN PICTURE CARRIES WATER UNDER INTERSECTION OF HIGHWAYS U AND A.
